# TEST REPORT

Product Name : DexSense 3D industrial camera  
Trade Mark : N/A  
Model(s) : FINCH, FINCH-W

Test Date : Jun. 07, 2025 - Jun. 12, 2025  
Date of Report : Jun. 23, 2025  
Report No. : DACE250609002PF001

| <b>TEST REPORT</b><br><b>IEC 60529</b><br><b>Degrees of protection provided by enclosures (IP Code)</b> | | <br>000006519 |

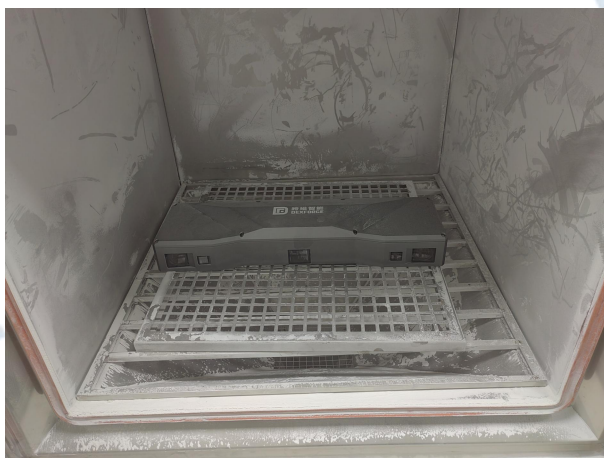
### Test Photos:

The protection is satisfactory if no deposit of dust is observable inside the enclosure at the end of the test.

| Sample No. | Test Result | Conclusion |
|---|---|---|
| 1# | The appearance and function are normal before and after test.<br>After testing, no dust deposition was observed inside the sample, and the sample can still function normally. | Pass |

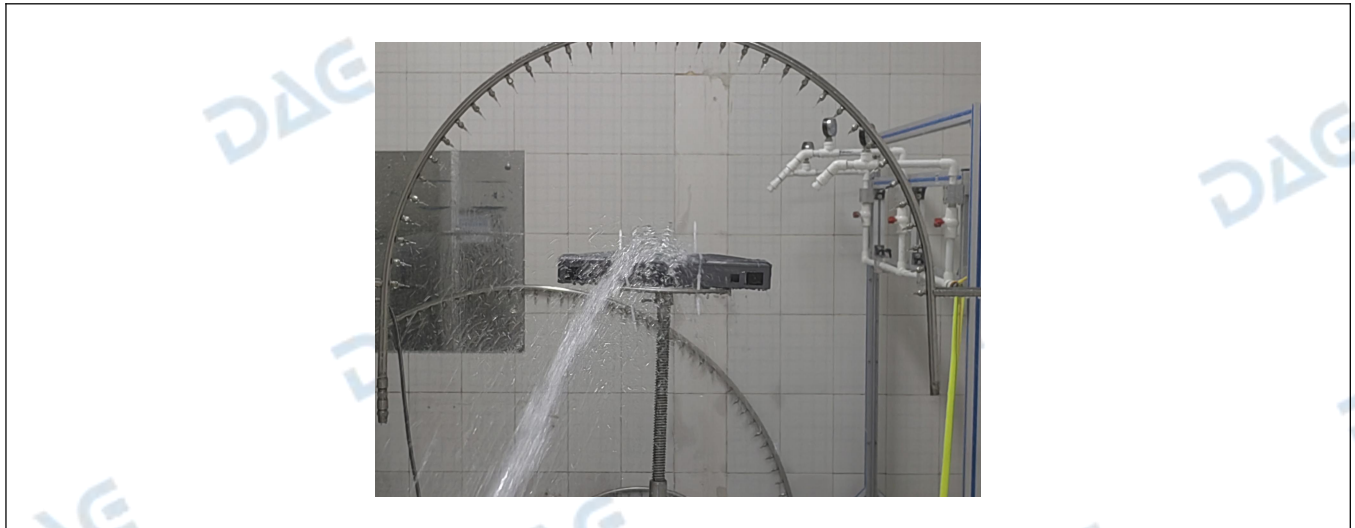
#### Test Photos:

internal diameter of the nozzle: 6.3 mm  
distance from nozzle to enclosure surface: Between 2.5m and 3m  
Duration of test: 3min

| Sample No. | Test Result | Conclusion |
|---|---|---|
| 1# | The appearance and function are normal before and after test.<br>No water deposition was observed internally, and the sample is still functioning normally. | PASS |
