## TEST REPORT

Product Name : DexSense 3D industrial camera  
Trade Mark : N/A  
Model(s) : KINGFISHER, KINGFISHER-S

Test Date : Jun. 07, 2025 - Jun. 12, 2025  
Date of Report : Jun. 23, 2025  
Report No. : DACE250609001PF001

| <p style="text-align: center;"><b>TEST REPORT</b><br/> <b>IEC 60529</b><br/> <b>Degrees of protection provided by enclosures (IP Code)</b></p> | | <br><small>CHECK</small><br>000006520 |

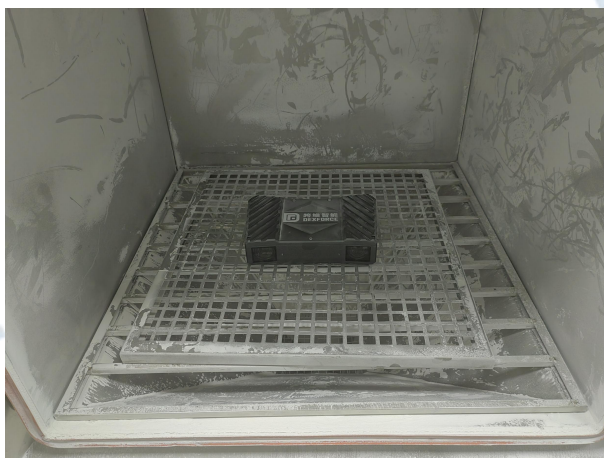
### Test Photos:

Client Requirements: Vacuum and test with talc powder for 8 hours.

The protection is satisfactory if no deposit of dust is observable inside the enclosure at the end of the test.

| Sample No. | Test Result | Conclusion |
|---|---|---|
| 1# | The appearance and function are normal before and after test.<br>After testing, no dust deposition was observed inside the sample, and the sample can still function normally. | Pass |

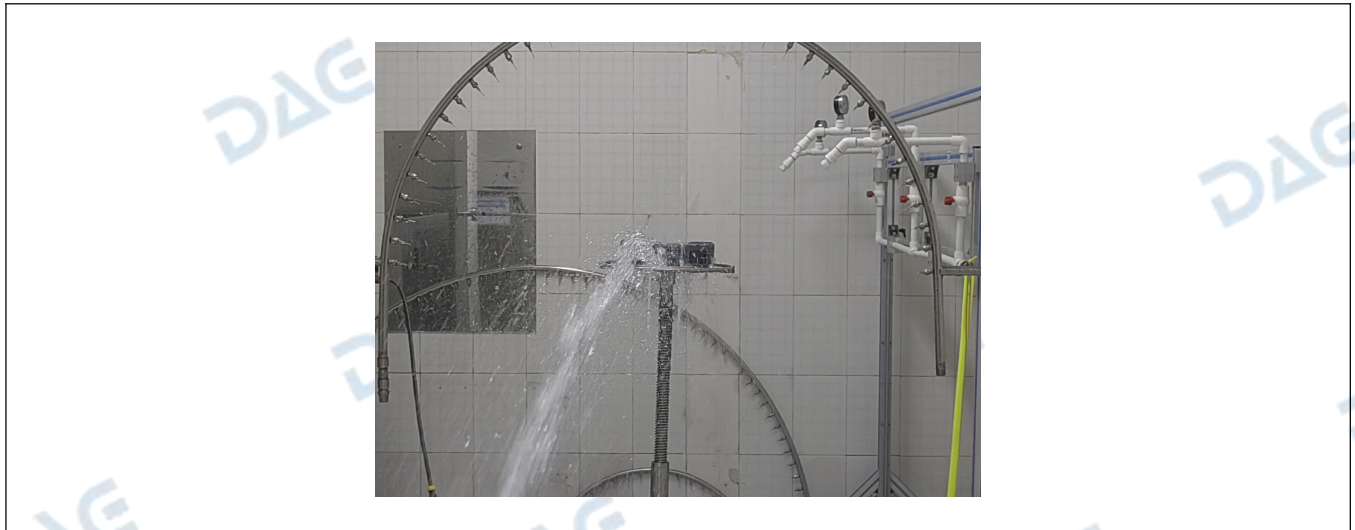
#### Test Photos:

internal diameter of the nozzle: 6.3 mm  
distance from nozzle to enclosure surface: Between 2.5m and 3m  
Duration of test: 3min

| Sample No. | Test Result | Conclusion |
|---|---|---|
| 1# | The appearance and function are normal before and after test.<br>No water deposition was observed internally, and the sample is still functioning normally. | PASS |

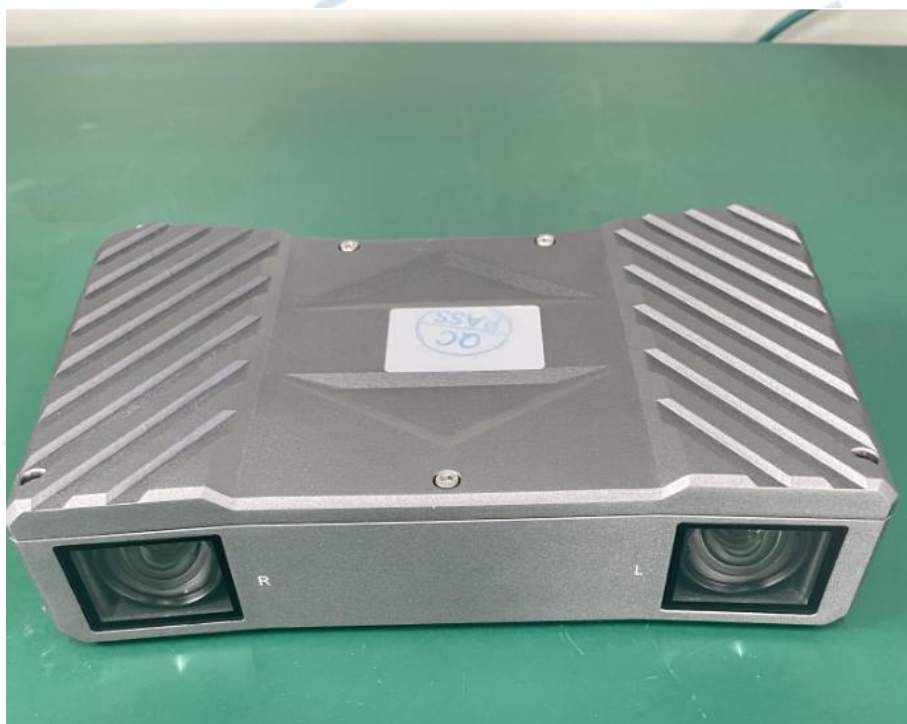
Photo 3  
(Series model:  
KINGFISHER-S)

– The main test model KINGFISHER has the same external dimensions as the series models, but its internal functions and accessories are different
