# TEST REPORT

Product Name : DexSense 3D industrial camera

Model(s) : SPARROW, SPARROW-D, SPARROW-DC

Report No. : DACE250609003PF001

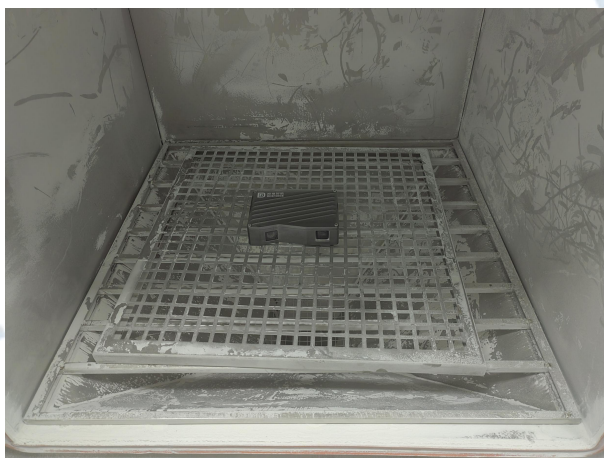
### Test Photos:

| Sample No. | Test Result | Conclusion |
|---|---|---|
| 1# | The appearance and function are normal before and after test.<br>After testing, no dust deposition was observed inside the sample, and the sample can still function normally. | Pass |

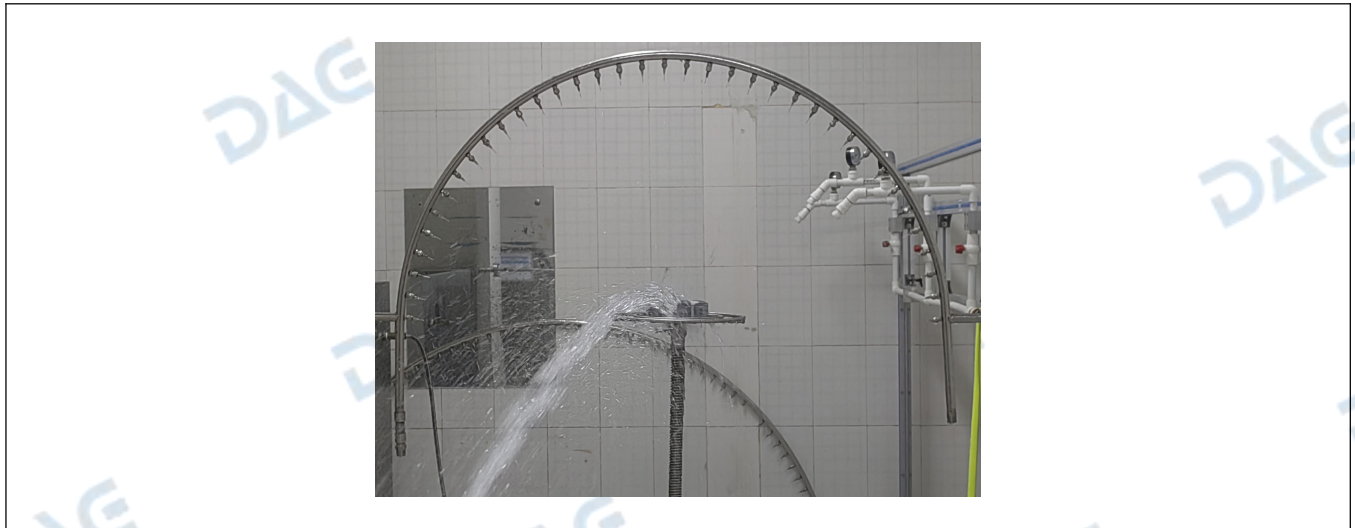
#### Test Photos:

| Sample No. | Test Result | Conclusion |
|---|---|---|
| 1# | The appearance and function are normal before and after test.<br>No water deposition was observed internally, and the sample is still functioning normally. | PASS |

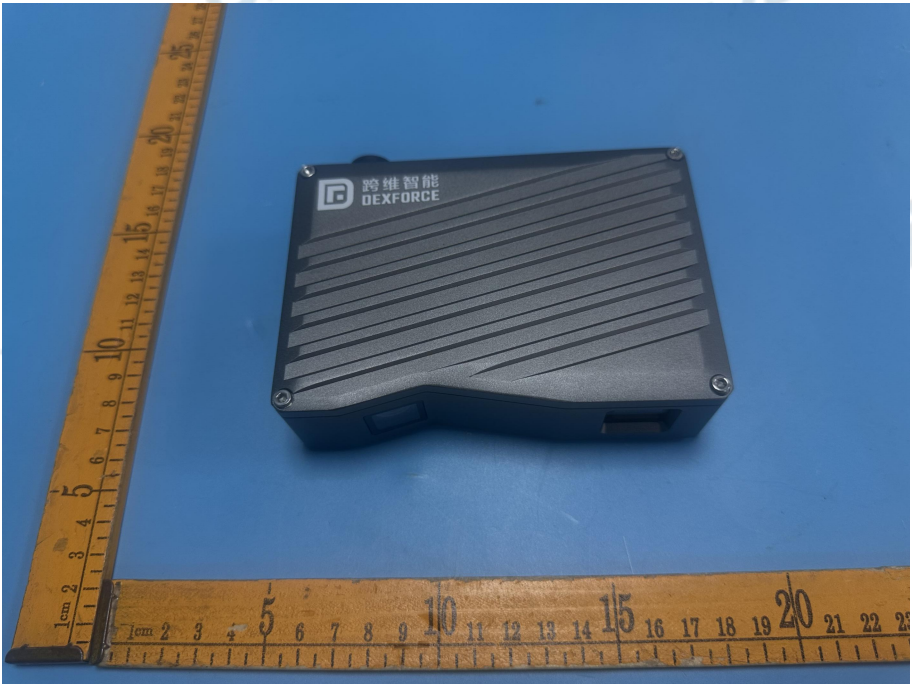
| <p>Photo 1<br/>(Before testing)</p> | <p>A black, rectangular electronic device with a textured surface and a logo that reads 'DEXFORCE' and '跨维智能'. It is placed next to a wooden ruler for scale. The ruler shows the device is approximately 10 cm wide and 5 cm high.</p> |
